Report

District of Summerland

Dam Safety Review

December 2010

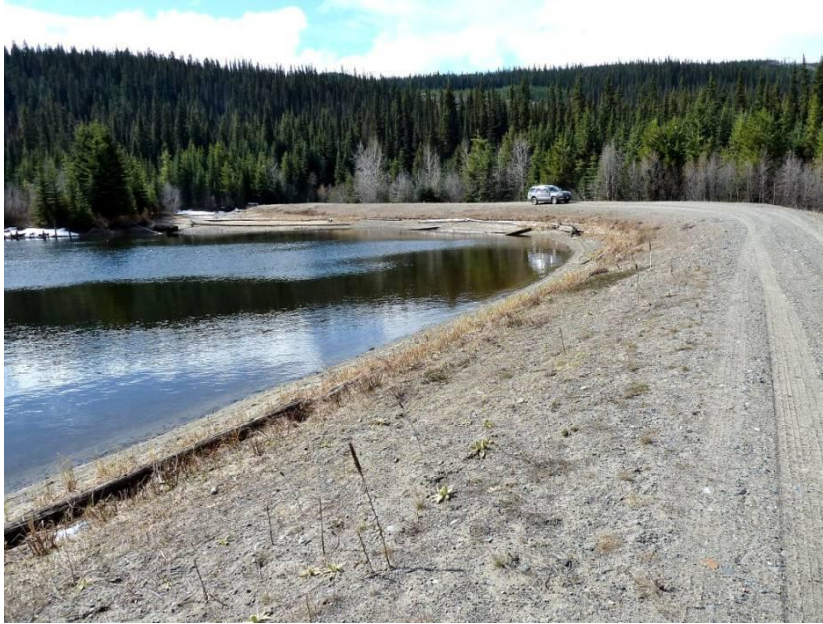
Photo 1.1. U/S Slope of dam – Good condition

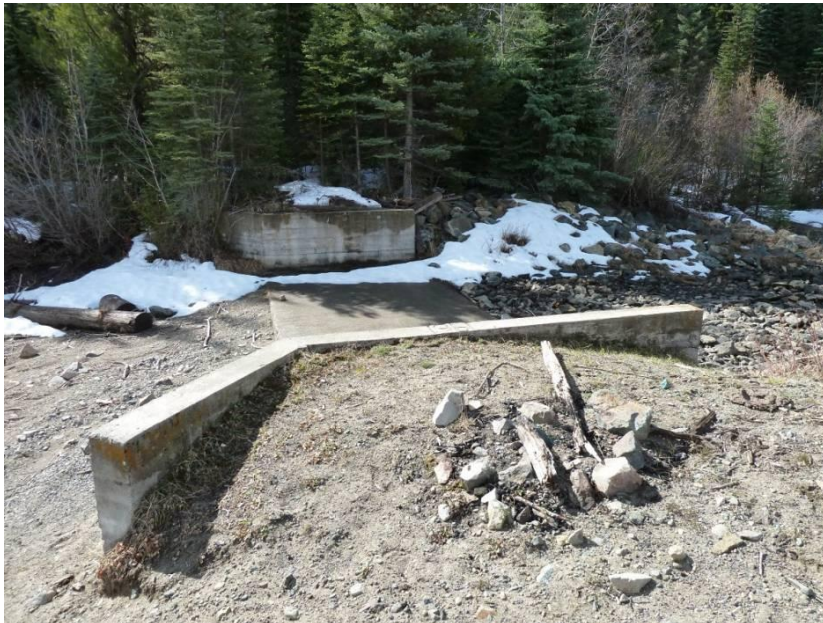
Photo 1.2. Emergency Spillway – Concrete is structurally sound. Note backfill needs and brush removal on far abutment.

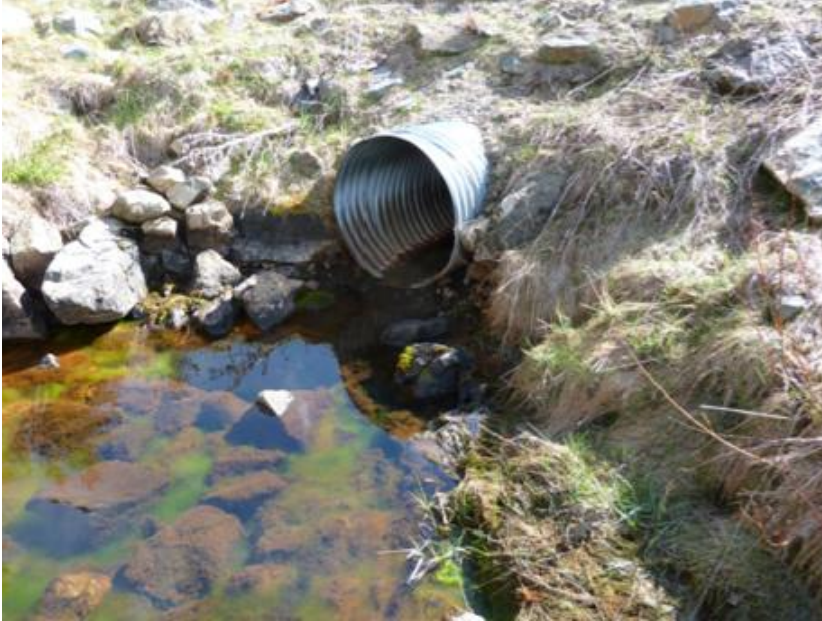
Photo 1.3. Low Level Outlet Structure

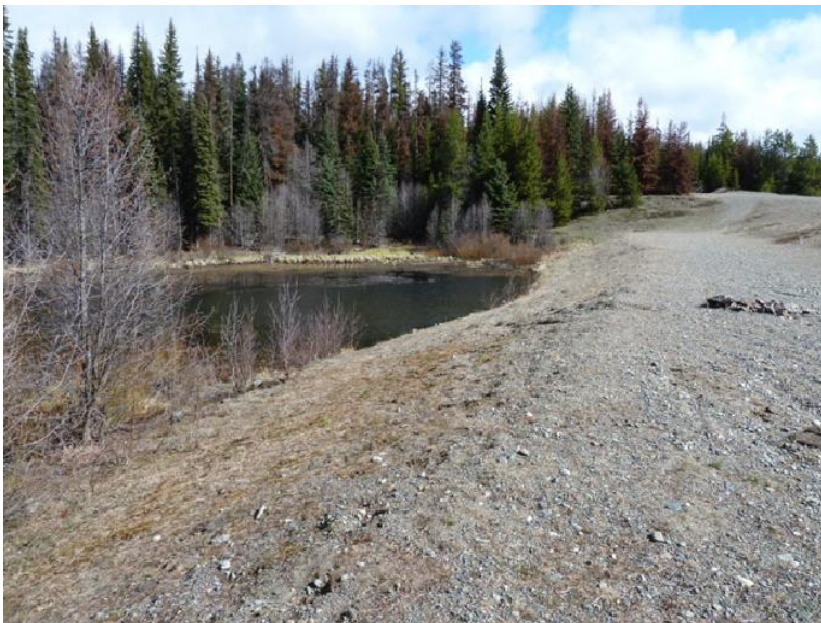
Photo 1.4. General Note: D/S Berm constructed in 2000.

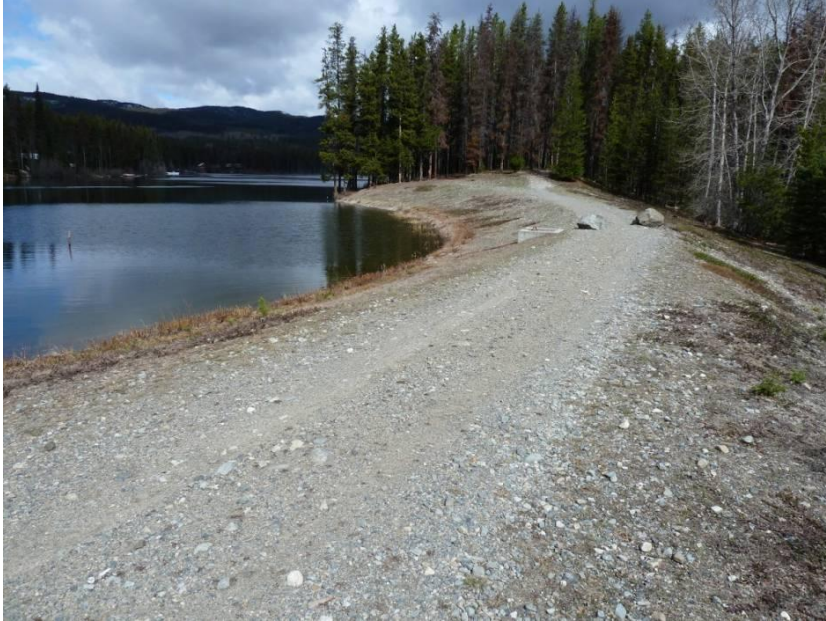
Photo 2.1 Slopes of dam – Good condition

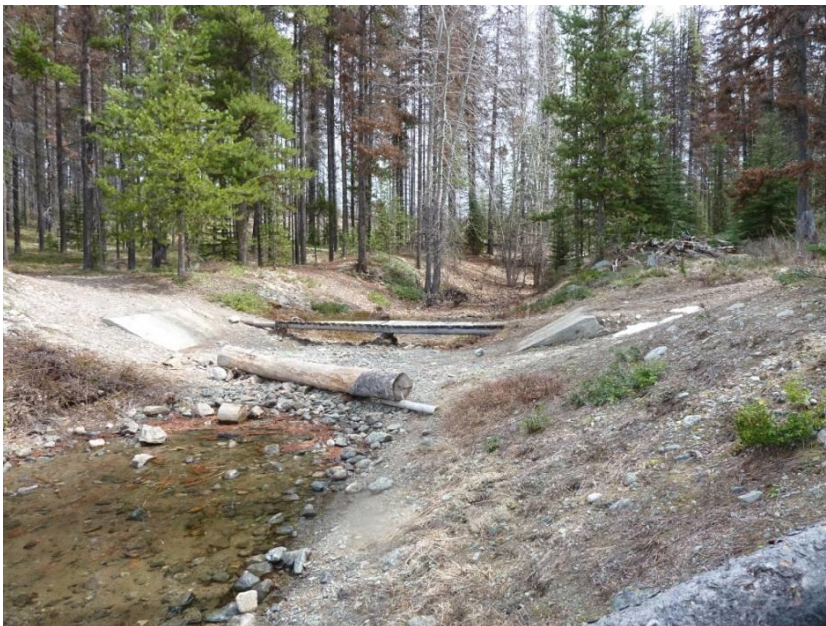
Photo 2.2 Emergency Spillway – Good condition. Requires monitoring for excessive public access and placement of logs and bridges.

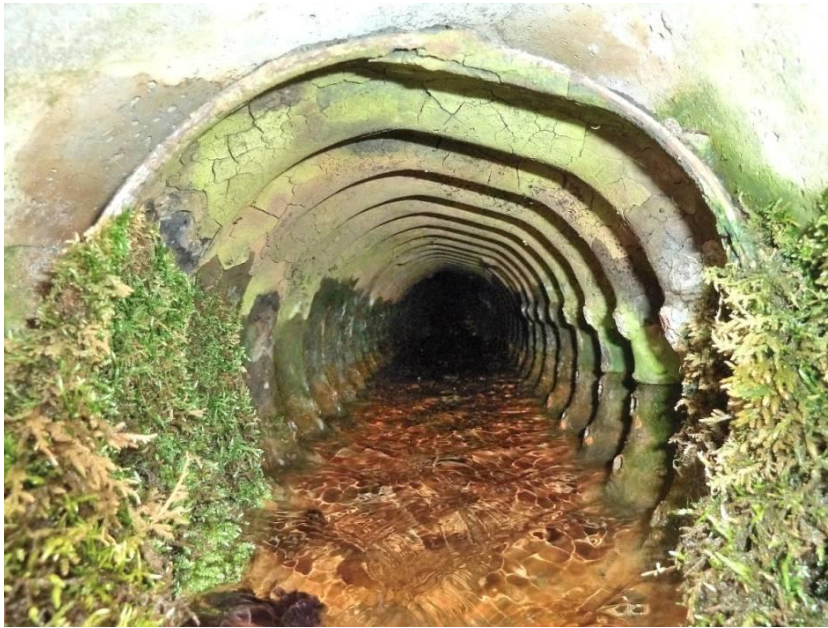
Photo 2.3 Low Level Outlet Structure – Deflection in outlet of CSP pipe. Monitor for further deflections or failure. Requires more frequent exercise to clear dirt and debris.

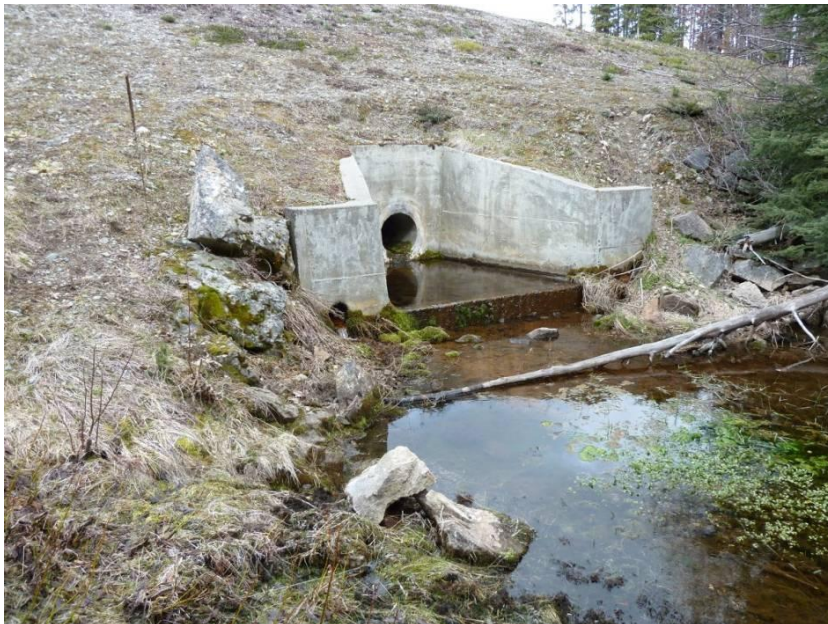
Photo 2.4. General Note: Outlet Structure in good shape. .

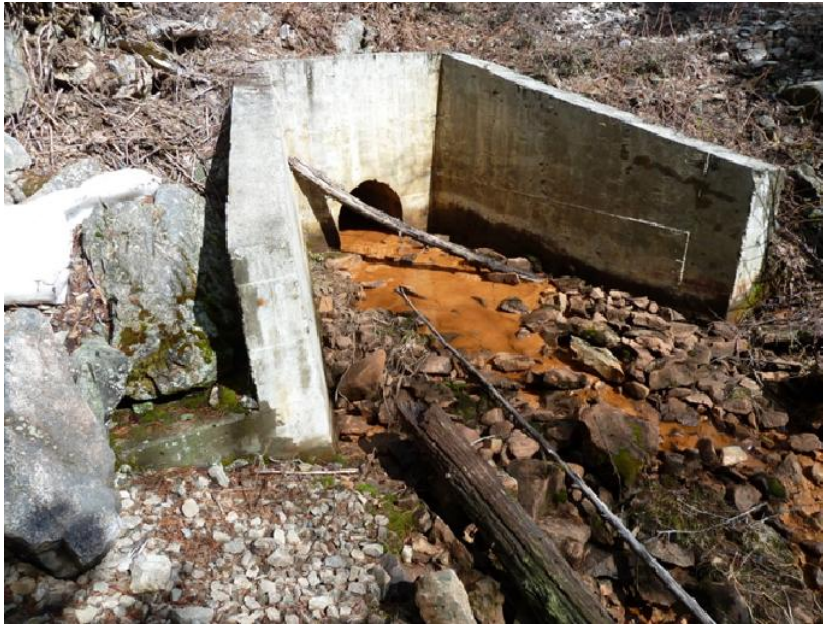
Photo 3.1 Low Level Outlet – Backfill and replacement of riprap required around structure. Rocks, debris and dirt clog outlet.

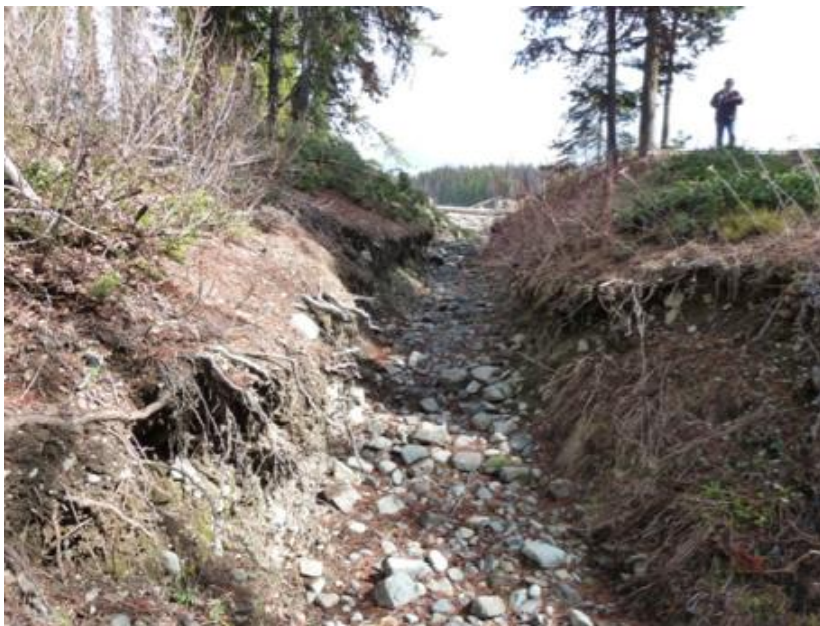
Photo 3.2 Emergency Spillway – Signs of significant use. Channel requires shaping. Potential for log jam is high.

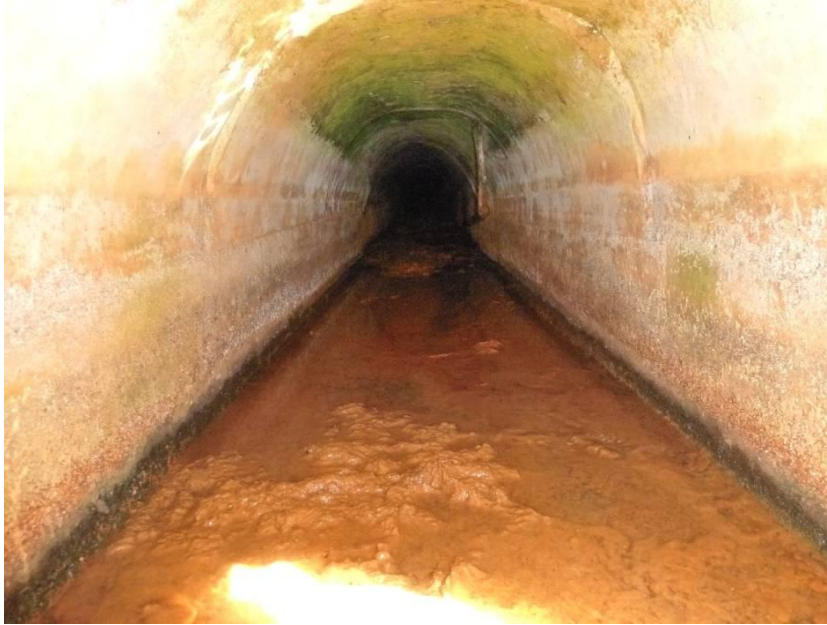
Photo 3.3 Low Level Outlet Structure – parabolic channel in good condition. Requires more frequent exercise to clear dirt and debris.

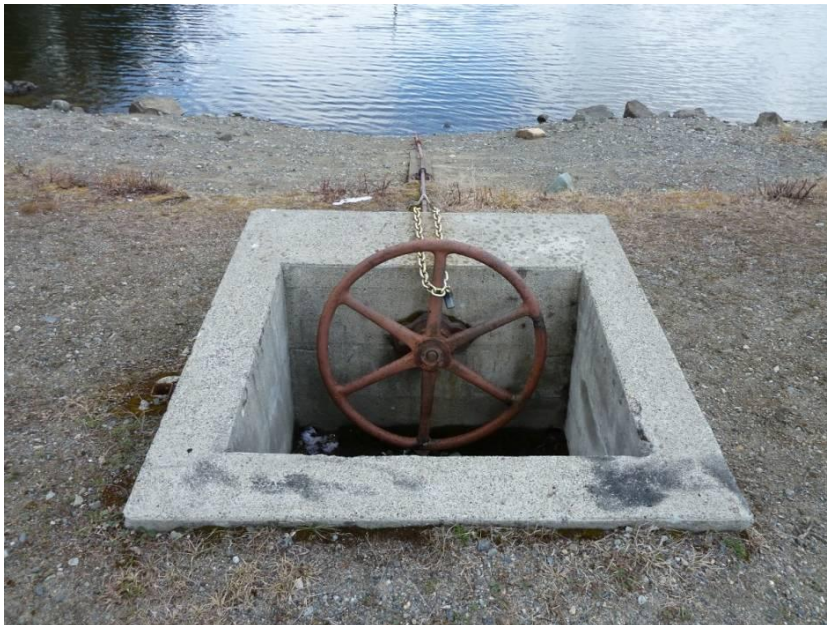
Photo 3.4. General Note: Low Level Gate in fair condition.

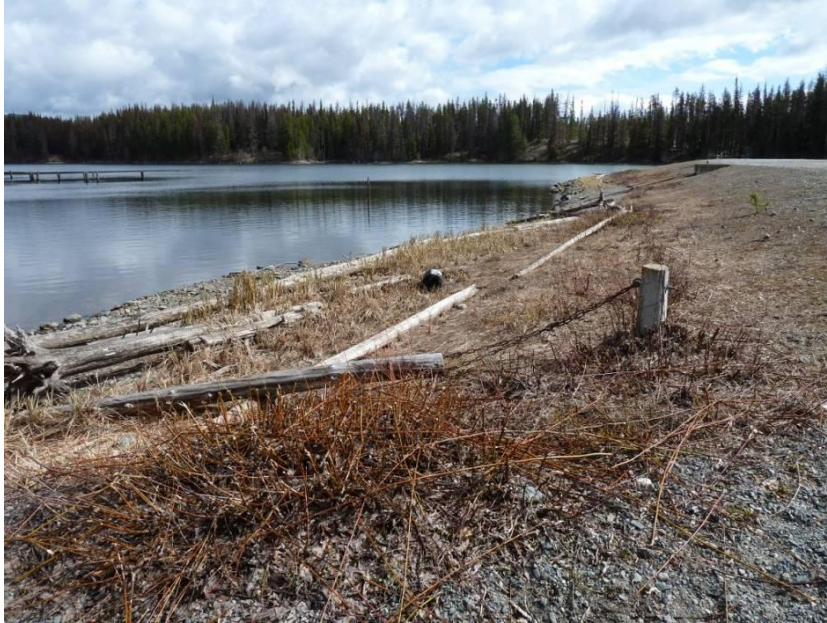
Photo 4.1 U/S Slope of dam – Good condition. Note old log boom.

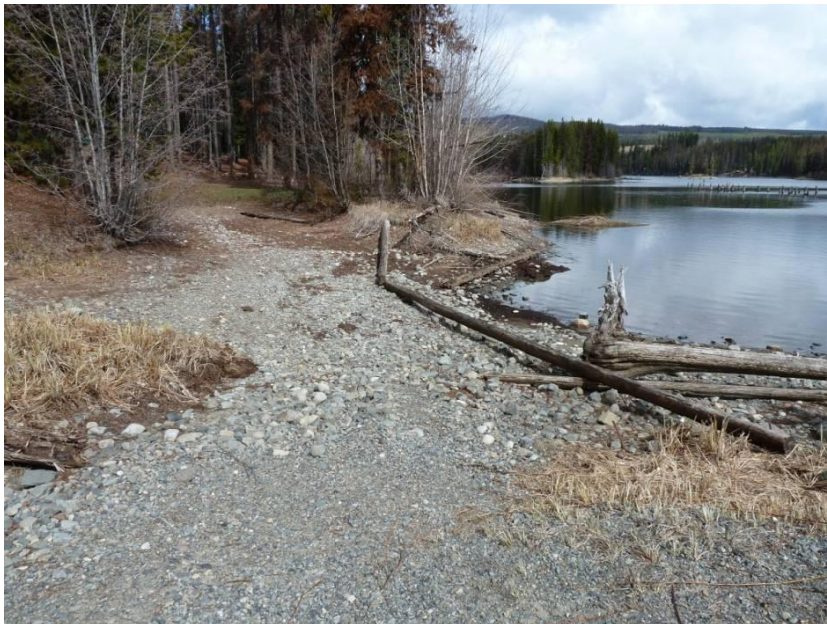
Photo 4.2 Emergency Spillway – Not well defined. Channel requires shaping. Some minor potential for log jams.

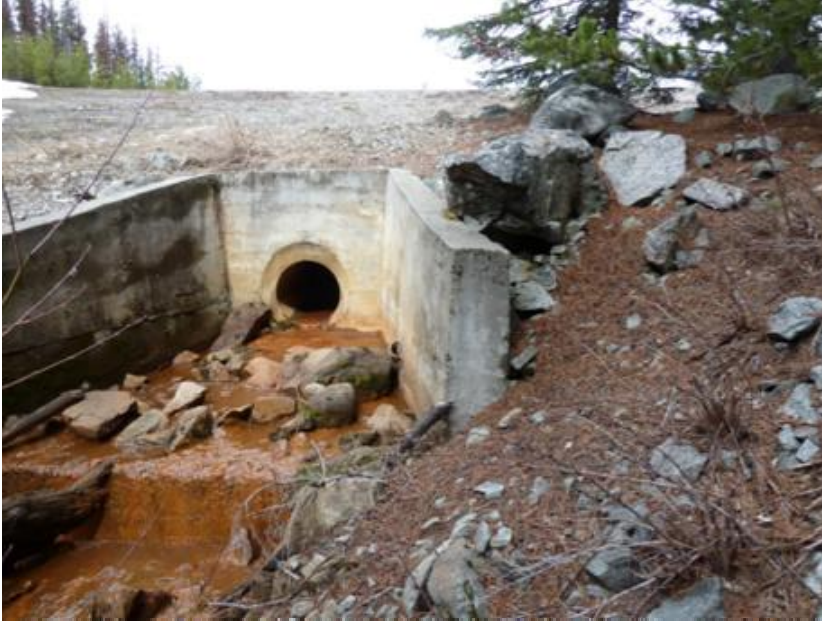
Photo 4.3 Low Level Outlet Structure – Backfill and riprap should be maintained. Rock was plugging outlet at time of inspection. Requires more frequent exercise to clear dirt and debris.

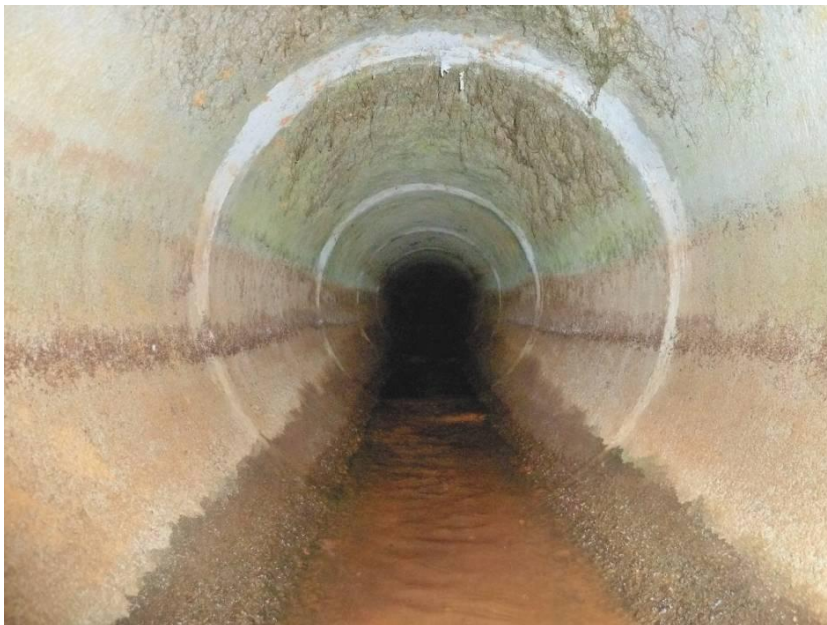
Photo 4.4. General Note: Concrete Conduit in good condition.

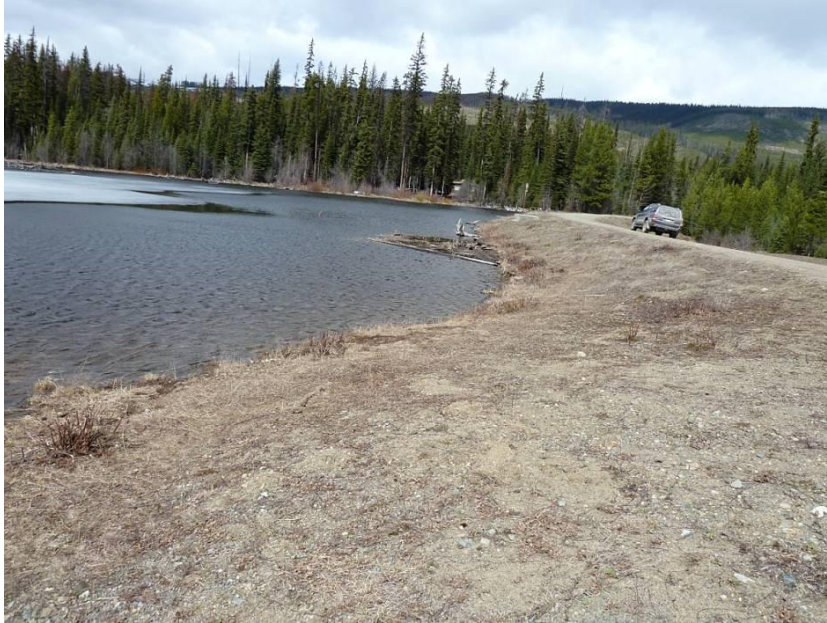
Photo 5.1 U/S Slope of dam – Fair-Good condition. Note old vertical intake pipe.

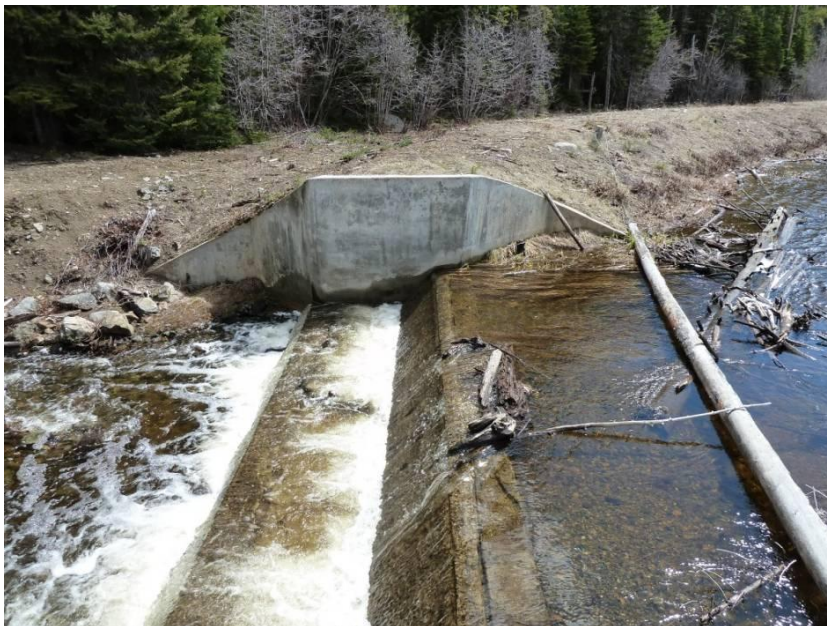
Photo 5.2 Emergency Spillway – Operational. Log boom operational. Required minor cleaning and debris removal.

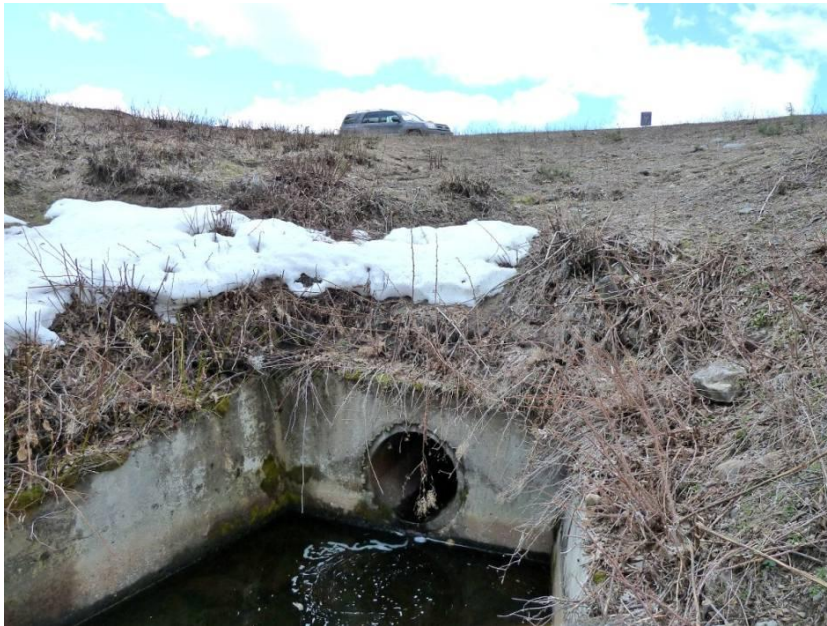
Photo 5.3 Low Level Outlet Structure – Earth backfill is sloughing over the concrete outlet. Brush has been removed. Maintenance required, including additional riprap.

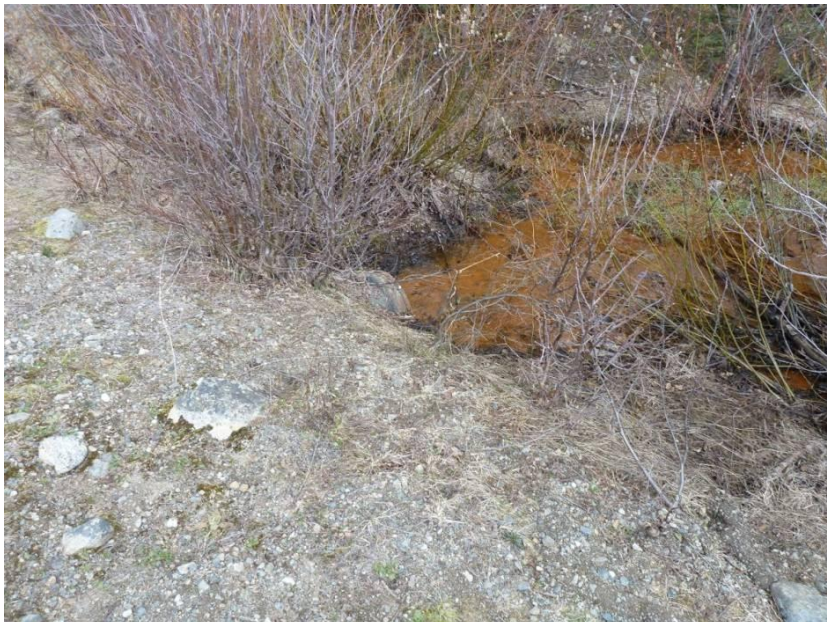
Photo 5.4. General Note: Old outlet structure has minor leakage. Frequent monitoring recommended.

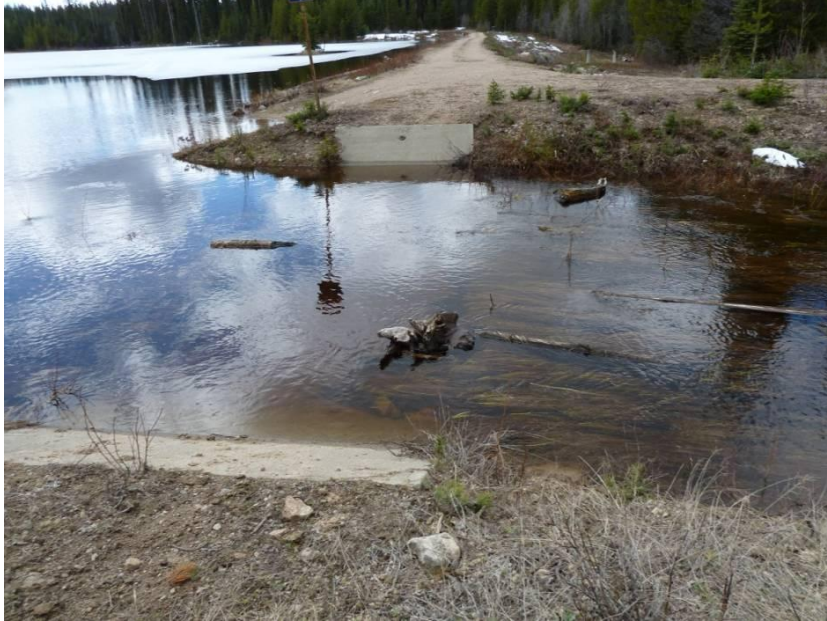
Photo 6.1 Looking across spillway and along center of dam. Water level was at or over FSL at inspection. Difficult to cross to visit dam.

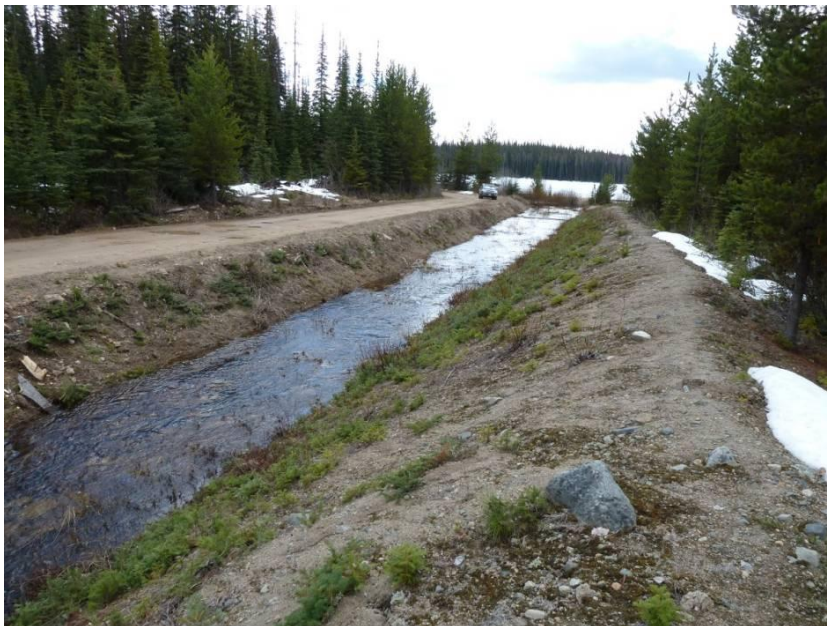
Photo 6.2 Emergency Spillway Channel – Operational. Channel maintenance and cleaning required on a regular basis.

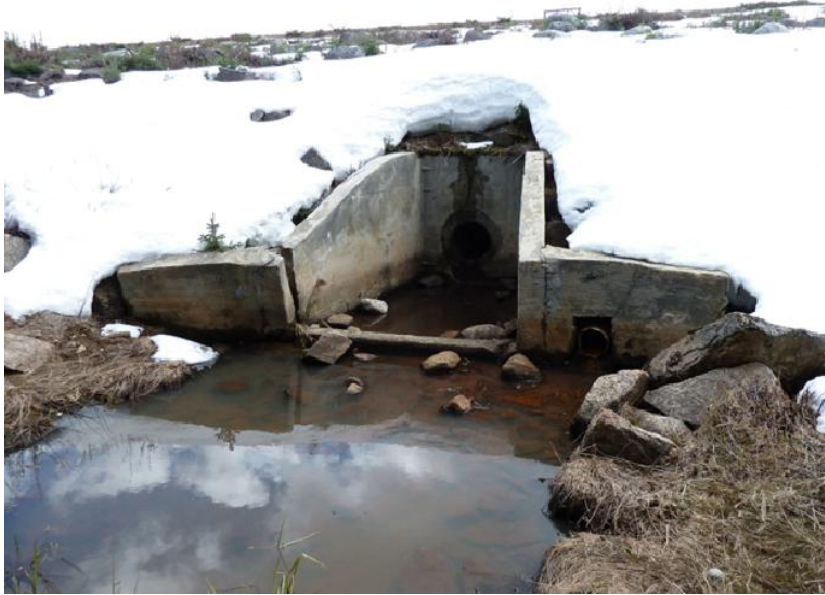
Photo 6.3 Low Level Outlet Structure – Concrete has failed in all directions. Earth sloughing.

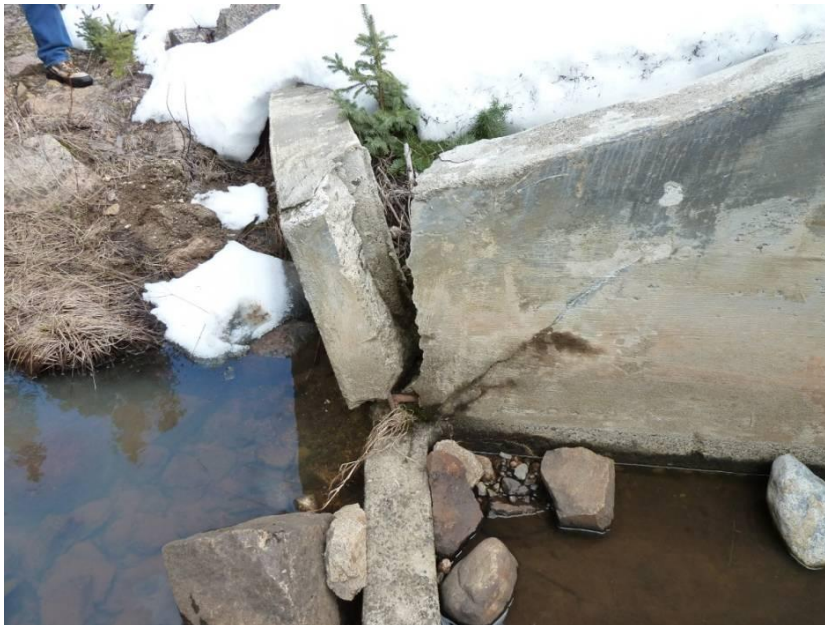
Photo 6.4. General Note: Concrete failure and significant Seepage.

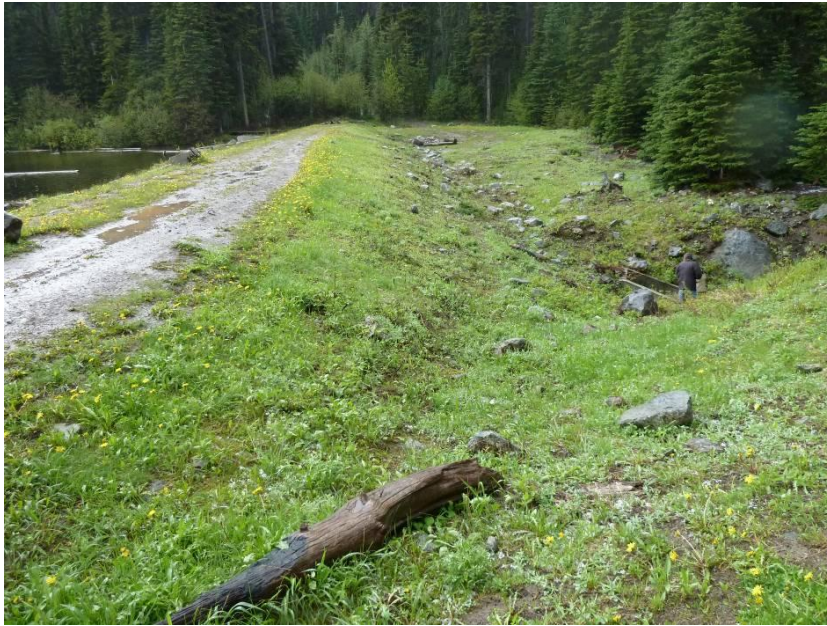
Photo 7.1 D/S abutment. Note low level outlet on right.

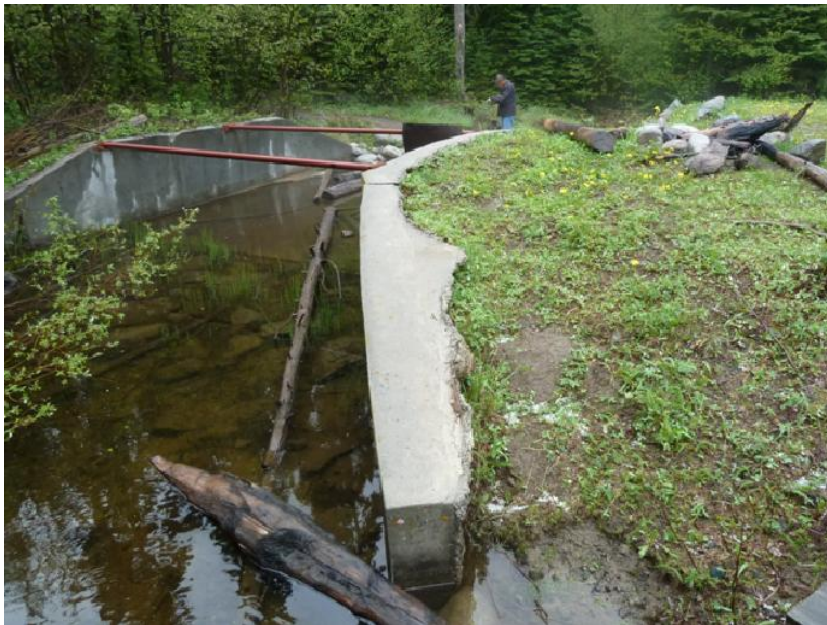
Photo 7.2 Emergency Spillway. Significant earth slouging and lack of riprap on both sides of vertical walls. Concrete failed in several locations.

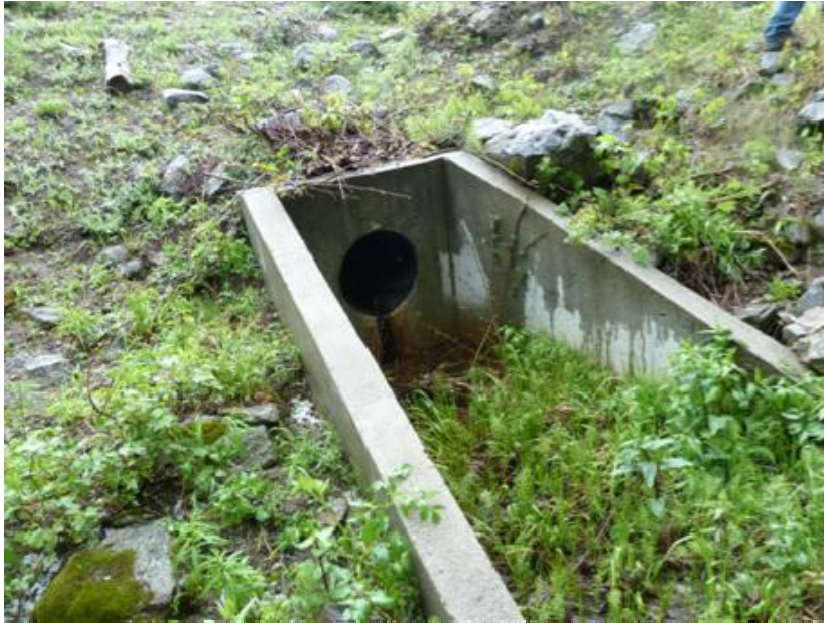
Photo 7.3 Low Level Outlet – concrete in good shape. Backfill and riprap require maintenance around structure. Some earth sloughing. Clean out of debris required.

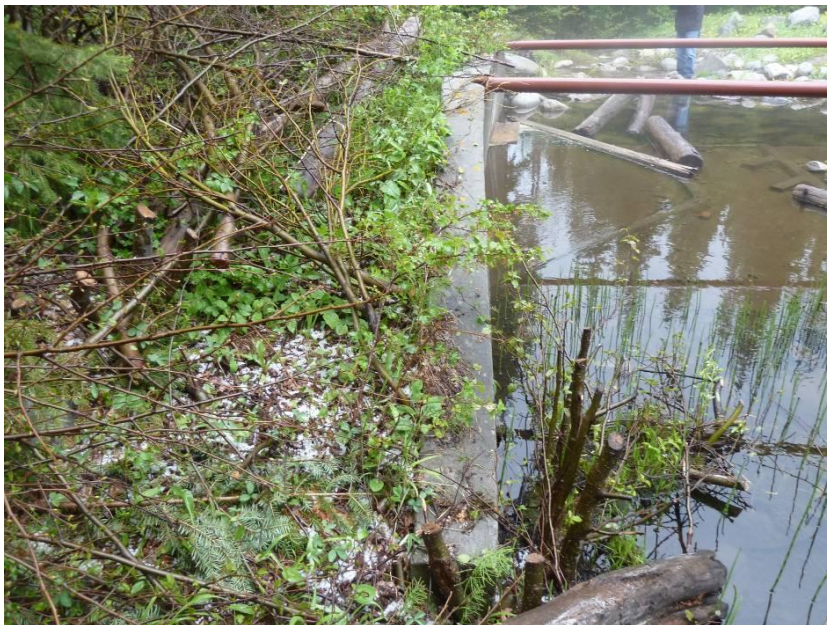
Photo 7.4. Emergency Spillway: Brush intrusion, earth sloughing, excess debris and concrete failures.

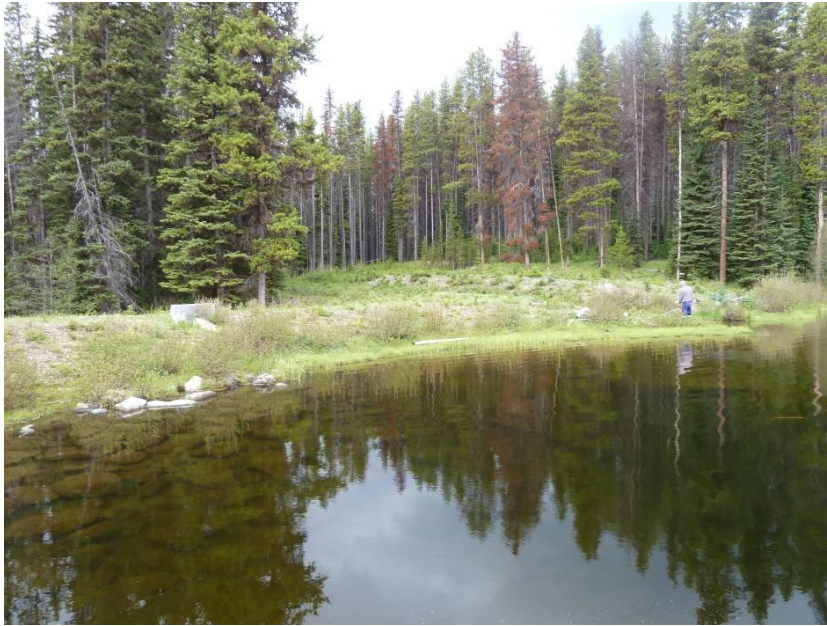
Photo 8.1 Looking at U/S face of dam and spillway. Inspection is after 800 m hike through steep forest.

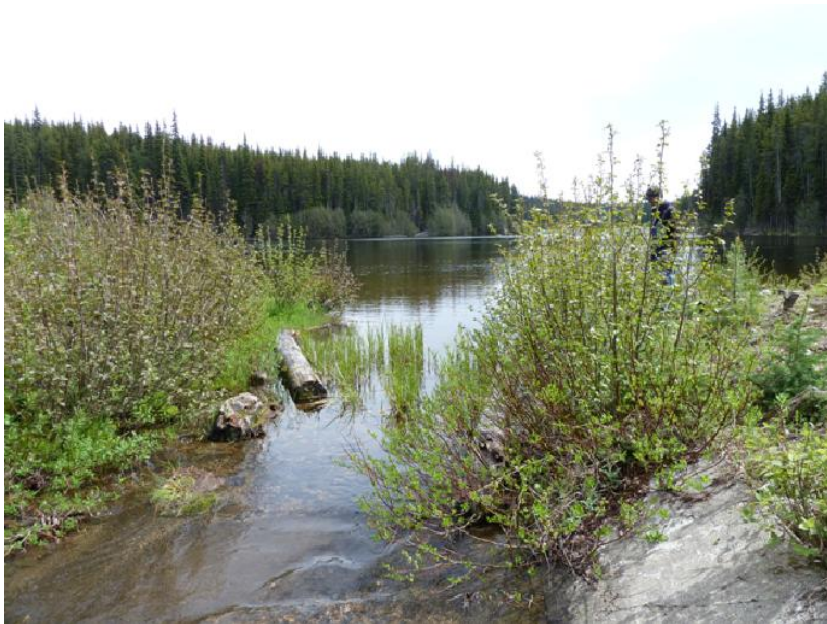
Photo 8.2 Emergency Spillway. Channel through dam. Minor brush removal required. (Performed during site visit). Note concrete entrance. No log boom.

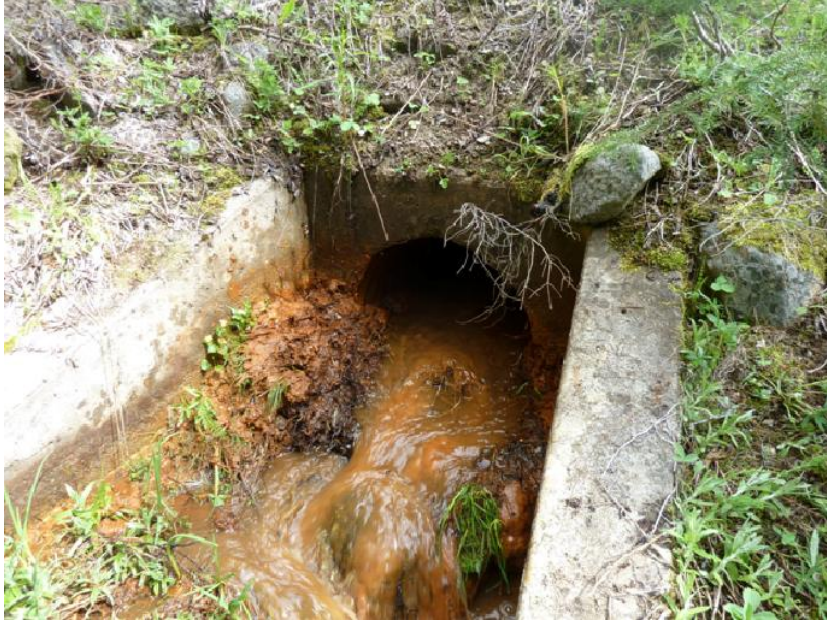
Photo 8.3 Low Level Outlet – concrete in good shape. Backfill and riprap require maintenance around structure. Some earth sloughing. Maintenance was performed during inspection.

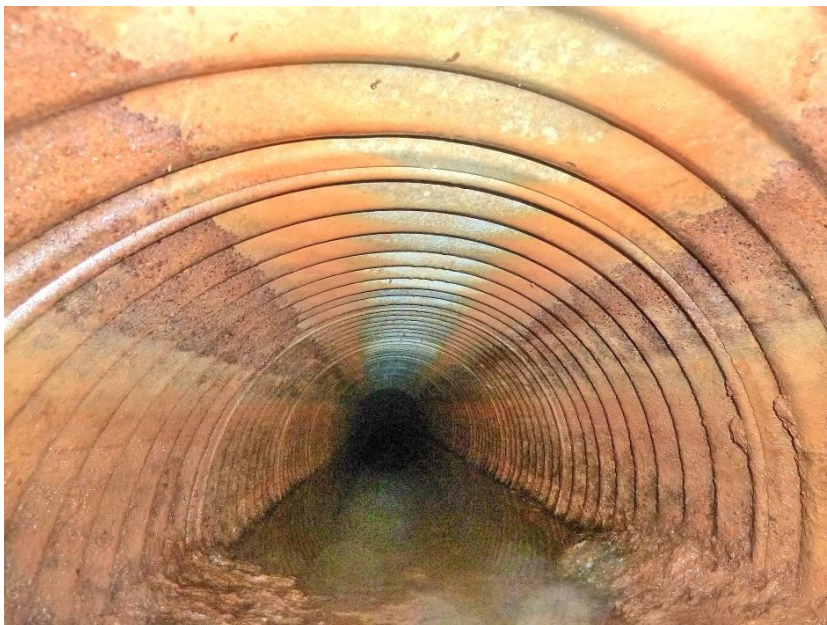
Photo 8.4 Low Level Outlet – Corrugated Steel pipe in fair condition.

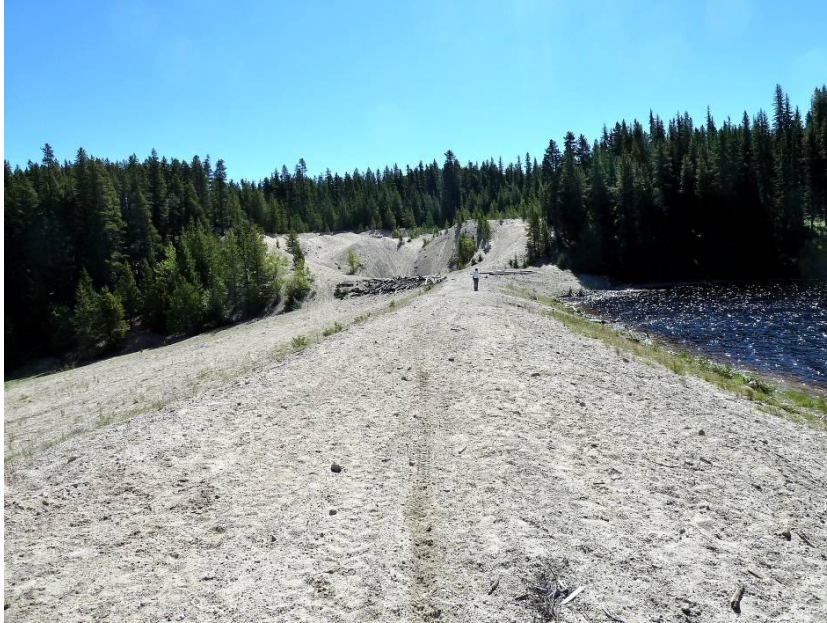
Photo 9.1 Significant footprints and traffic marks on gravelly sand material. Crest or road is undefined. Note gravel pit is popular motocross location.

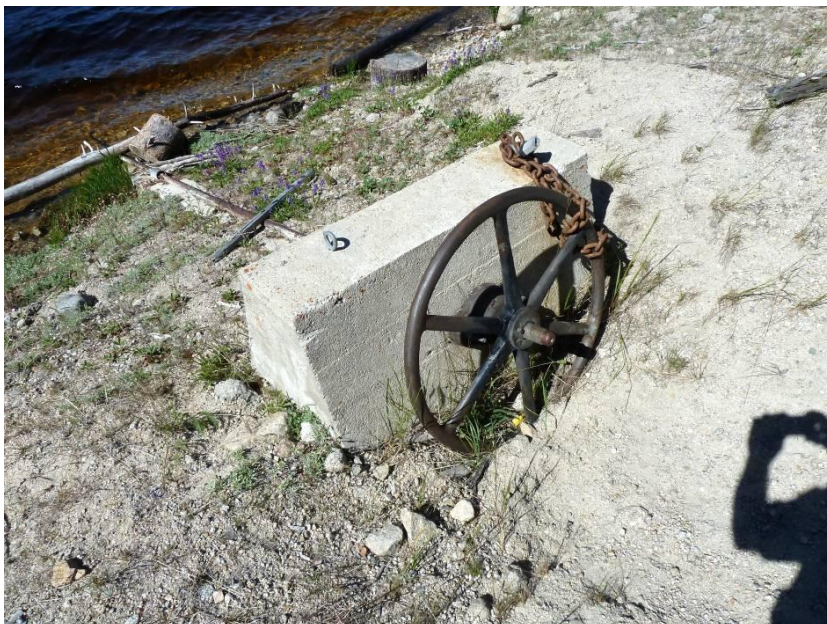
Photo 9.2 Low Level Outlet gate – Adjustment of backfill required to operate gate.

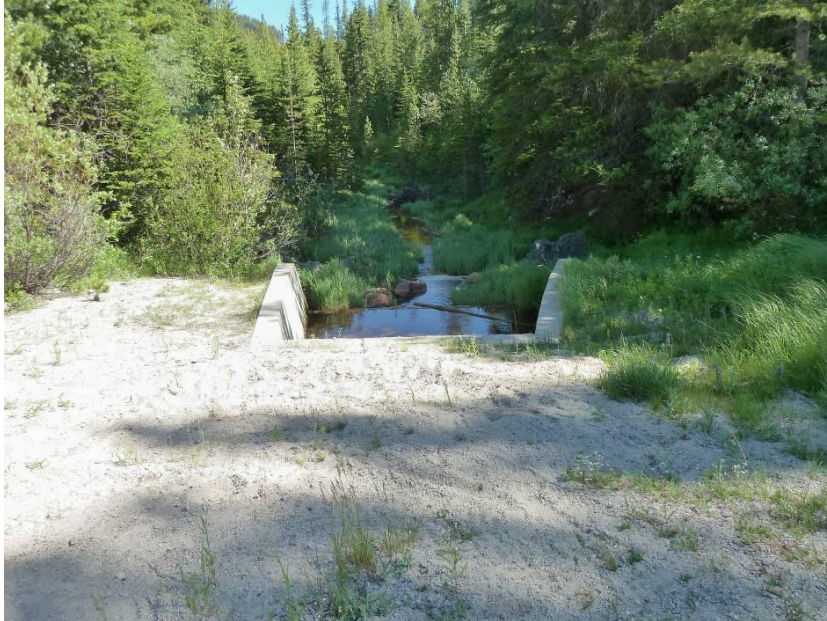
Photo 9.3 Low Level Outlet – concrete in good shape. Some seepage from abutment at structure. Some flow. Note water, but no flow from outlet.

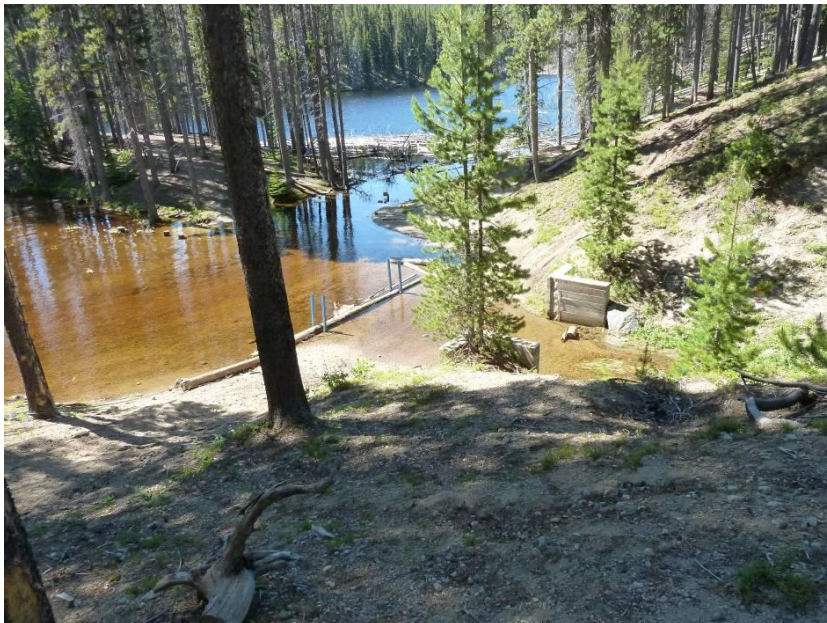
Photo 9.4 Emergency Spillway – Log Boom, channel in good condition.

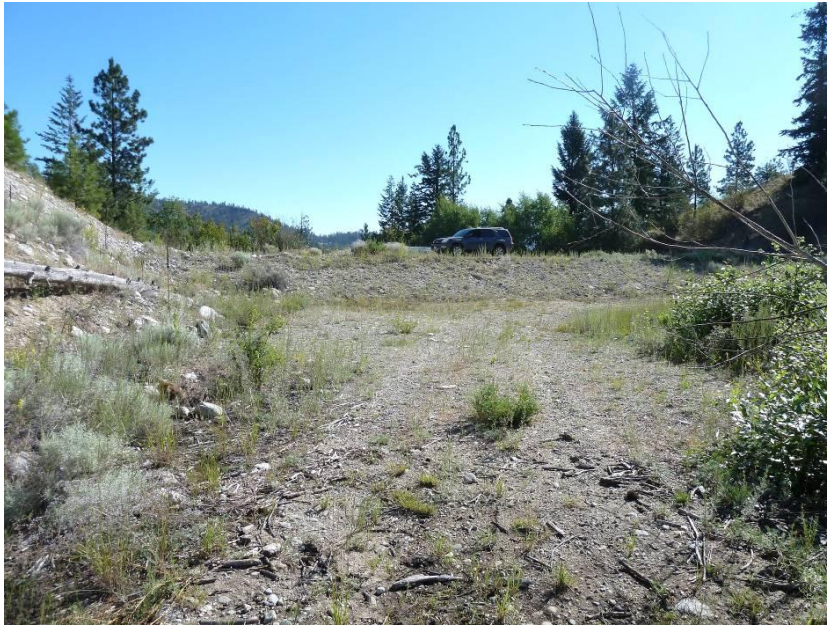
Photo 10.1 U/S pond level. Additional crest protection (note vehicle)

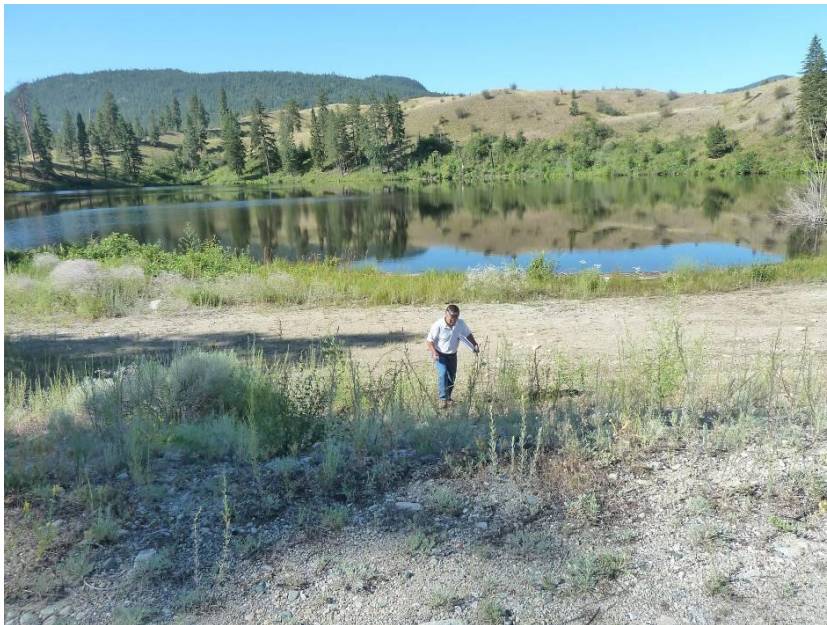
Photo 10.2 From top of dam. Pond elevation is maintained approximately 3 m below top of dam. No emergency spillway.

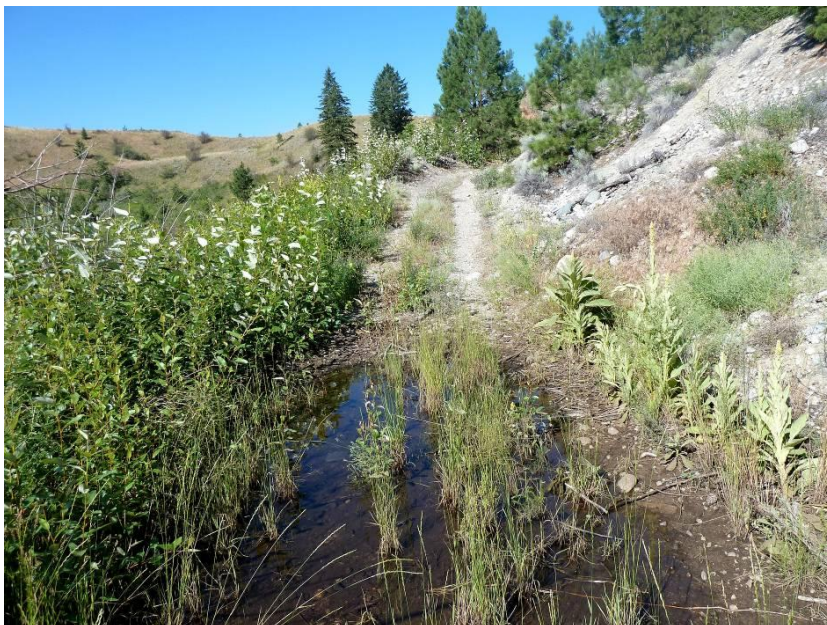
Photo 10.4 Groundwater intrusion along left edge of pond. Not part of dam.

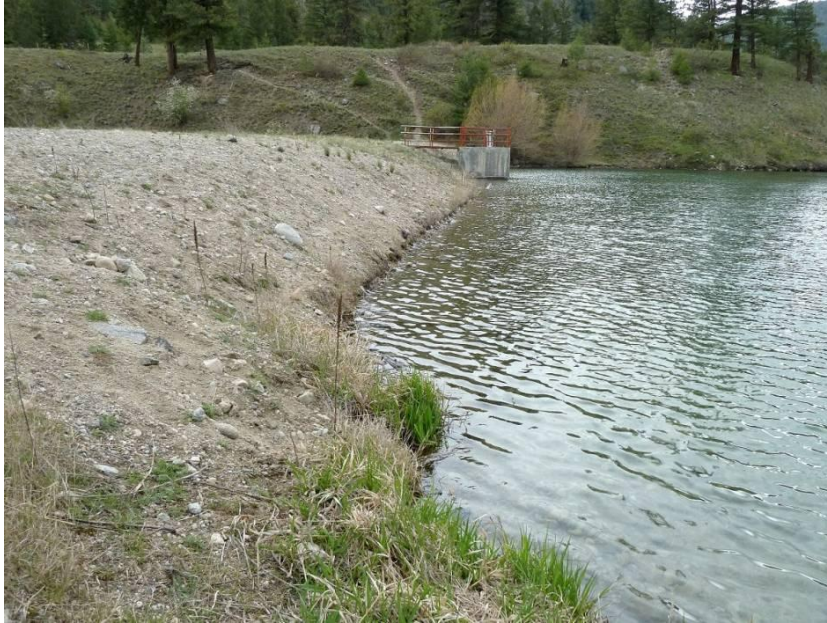
Photo 11.1 U/S Embankment – 1:1 slope, no riprap. Some erosion at base.

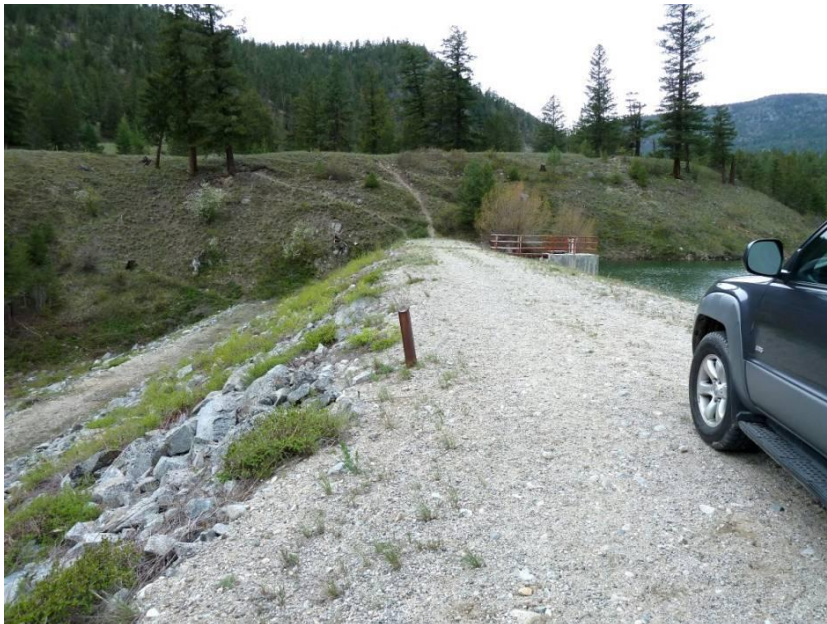
Photo 11.2 D/S Embankment – Steep slope. Riprap is not well defined.

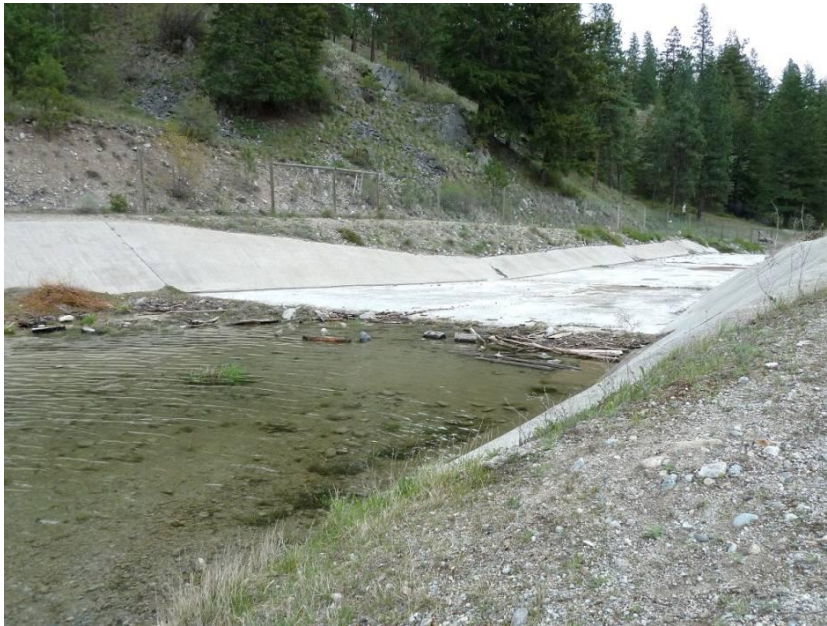
Photo 11.3 Emergency Spillway – Concrete spillway. Some shifting and cracking in concrete. Minor debris. Note road and safety fence.
