Report

District of Summerland

Dam Safety Review

December 2010

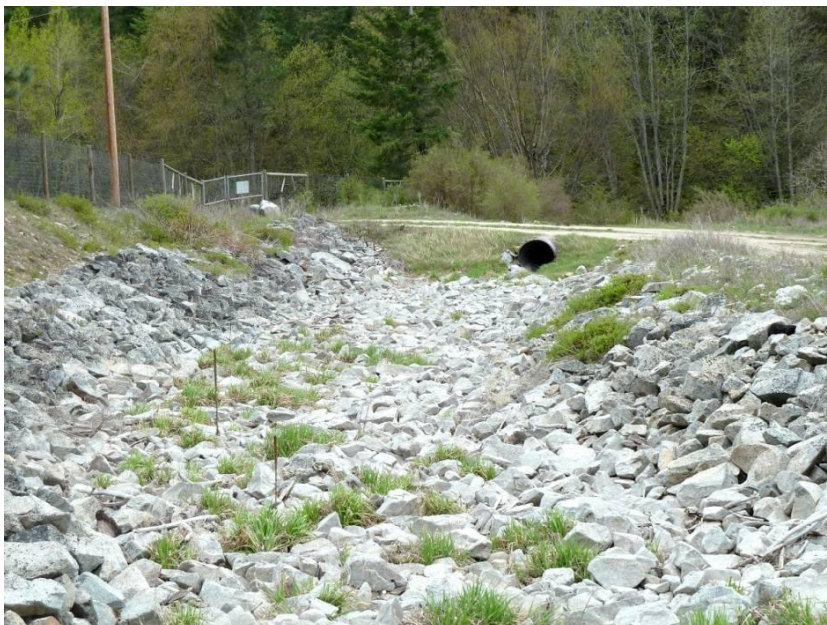
Photo 11.4 Emergency Spillway – Access Road and culvert. Good riprap cover. Culvert and road would likely be destroyed in a major storm event.

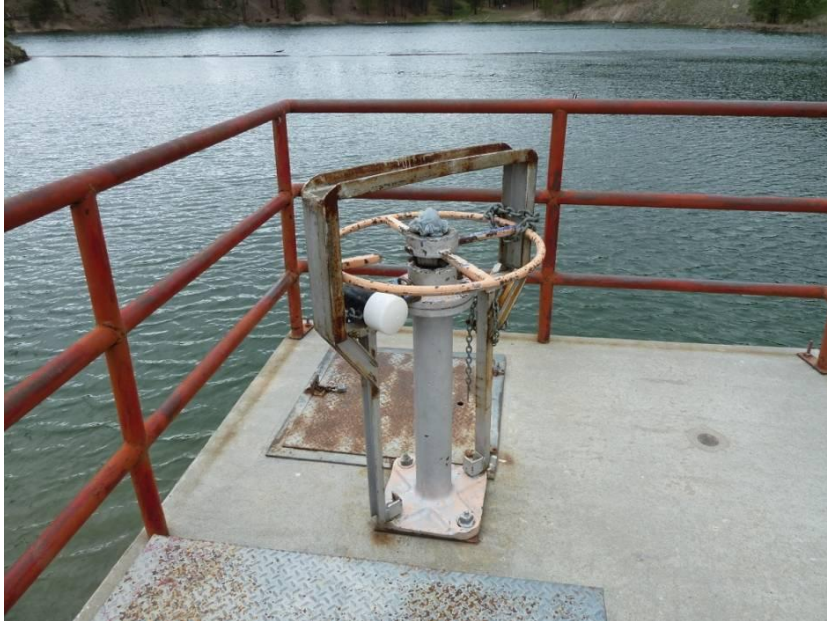
Photo 11.5 Low Level Outlet – Handwheel requires replacement.

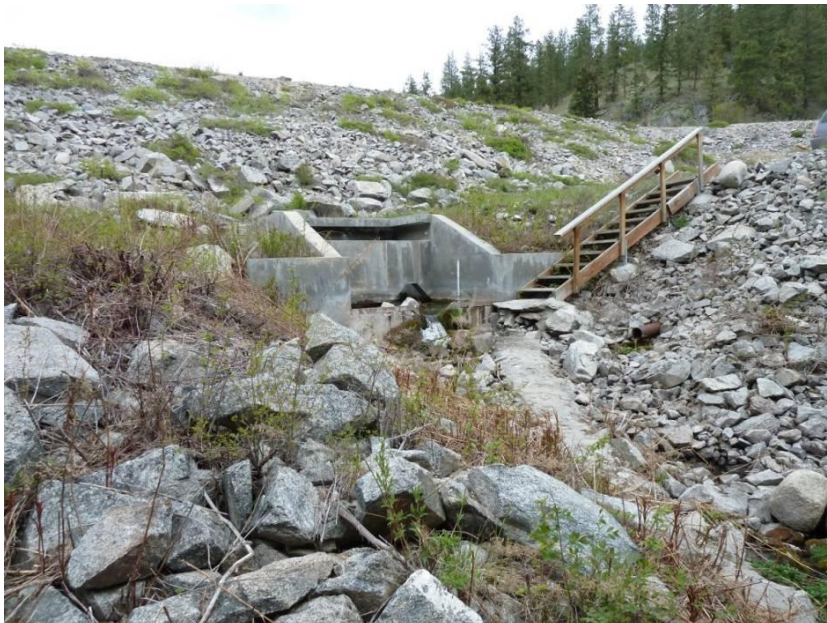
Photo 11.6 Low Level Outlet. Good condition. Seepage flow is from drain outlet beside the structure.
