ISINTOK RESERVOIR FLOOD INUNDATION REPORT

District of Summerland
January 10, 2012

Project No. 023-012

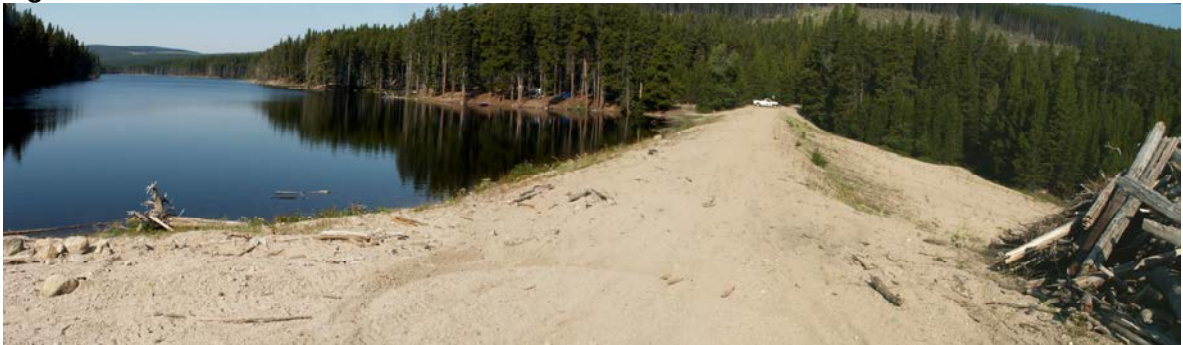
Figure 1.2 – Isintok Dam

The Isintok Dam is an earth filled Dam having a crest length of approximately 140 m, a height of 9.2 m, and a crest of 4.0 m. It has an upstream side-slope of 2:1 and a downstream side-slope of 3:1.

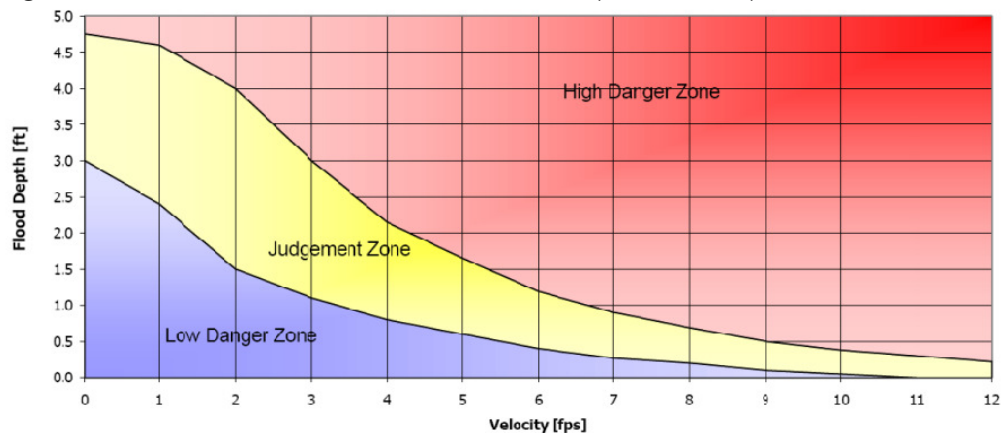
Figure 4.3 – Estimated Hazard Level for Adults (USBR, 1988)

A failure of the Isintok Dam carries a high potential for loss of life and damage to personal property. Although the extent of damage cannot be determined exactly, the hazard level for all areas inundated by flood waters can be estimated for adults, cars, and houses by flood depth and velocity as shown in Figures 4.3, 4.4 and 4.5 respectively.

Since only maximum water elevations are shown in the inundation mapping, it is important to note that damage would be created by not only the depth of flooding, but also the higher velocities. Table 4.1 in the previous section describes average velocities of the channel of up to approximately 10 m/s (36 km/h). The max velocities experienced at any station would be significantly higher. The narrower flood sections in the inundation plots are potentially much more hazardous. The following section describes the hazard levels associated with various flow velocities and water depths.
